High Test Peroxide Incident at Stennis Space Center

R. Ross, D. Sewell, M. Cockrell

Propulsion Test Directorate, Building 4010
NASA John C. Stennis Space Center, MS 39529
Telephone: (228)688-2320, Fax (228)688-1485, Robert.Ross@ssc.nasa.gov

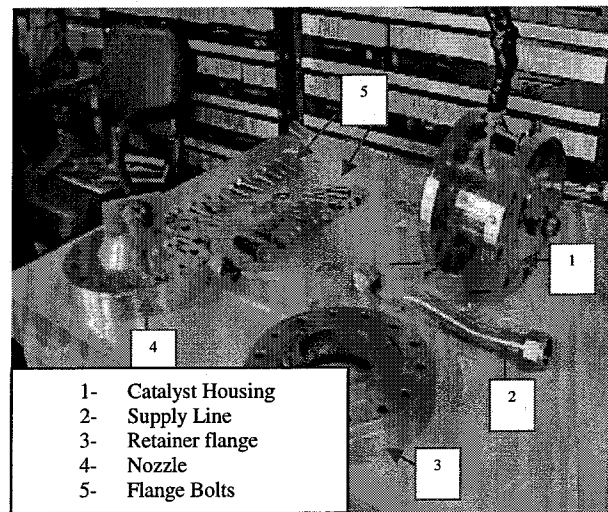
Figure 1: Test Hardware Overview

The event occurred approximately one second into the test following the completion of a successful test. Damage to the facility included rupturing a one inch diameter stainless steel supply line rated for 29 MPa (4200 PSI) and the destruction of a pre-valve rated for 20.7 MPa (3000 PSI) service. For the test article, fourteen 1.27 CM (0.5 inch) diameter stainless steel bolts failed in tension and a portion of the test article (~ 7.3 Kg or 16 Lbm) was ejected thirty meters from the test stand. Figures 1-4 show post test photographs of selected hardware.

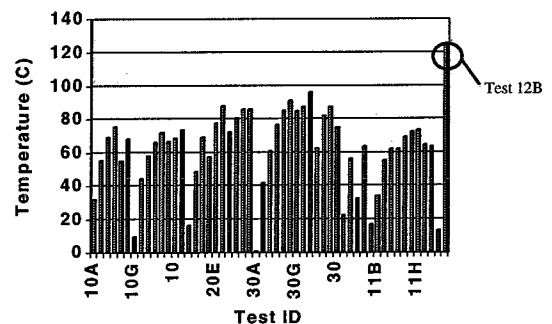
Figure 6: Test Article Initial Temperature

Figure 6 shows the initial temperature of the hardware for all of the tests in the series. At 121°C (250°F) the initial temperature for the final test was approximately 28 °C (50 °F) higher than previous tests. Figure 7 shows the transient response of the test article three minutes prior to the start of test. As shown in the figure, the test article is heated by the decomposing peroxide as it leaks from the valve and comes in contact with the catalyst. Additionally, peroxide vapor is created as a product of the liquid in contact with the hot test hardware.

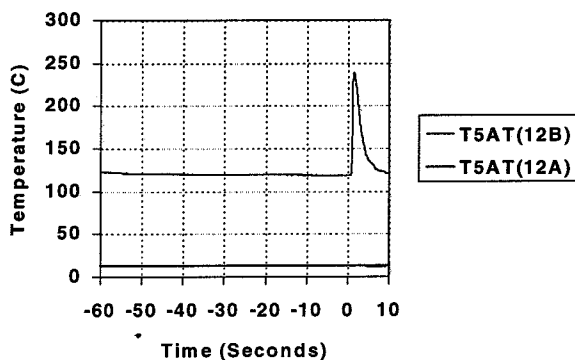
Figure 8: Thermal Response Data

Figure 8 shows the thermal response of the temperature sensor in the test article over a period of 70 seconds including one minute prior to the start of the test. The temperature sensor is located to measure the fluid temperature of the peroxide in the test article and the nominal test response is shown in test 12A. As shown in the figure, for test 12A the test article and fluid temperature were at ambient temperature prior to the start of the test. In contrast, the temperature at the start of test 12B increases over 110 °C (200°F) over a period of approximately one second. Heat is a byproduct of the peroxide decomposition reaction and the data show that there was a large amount of heat generated in a very short period of time.

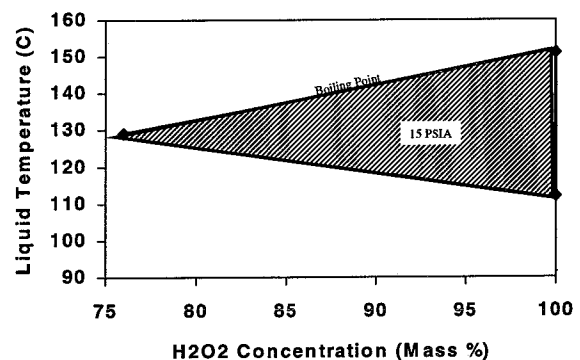
Figure 9: Critical Temperatures for Peroxide at Ambient Pressure

Critical vapor concentrations are well defined as a function of concentration and pressure [2]. Figure 9 shows the critical temperature range for generating potentially dangerous levels of peroxide vapor at ambient pressure. As shown in the figure, the critical temperature range increases as the concentration increases, thus, 98% concentration is more sensitive to temperature than 85%. For the case at hand, it is known that peroxide vapor/liquid was present and that the temperature was approximately 121°C (250°F) at the start of the final test. These conditions are sufficient to create a dangerous vapor concentration at the start of the test. In addition, Figure 10 shows the critical vapor concentration as a function of pressure. As shown in the figure, the relationship is logarithmic with respect to pressure and concentration and the critical concentration decreases as the pressure increases. A high but less than critical vapor concentration in the system at low pressure can translate into a dangerous level by increasing the pressure from ambient to normal operating pressures of 3.4 MPa (500 PSIA).
